ENGINEERING ETHICS

THE CASE OF THE LAKEWOOD "HI-STAK"

Department of Philosophy and Department of Mechanical Engineering
Texas A&M University

Accident Report

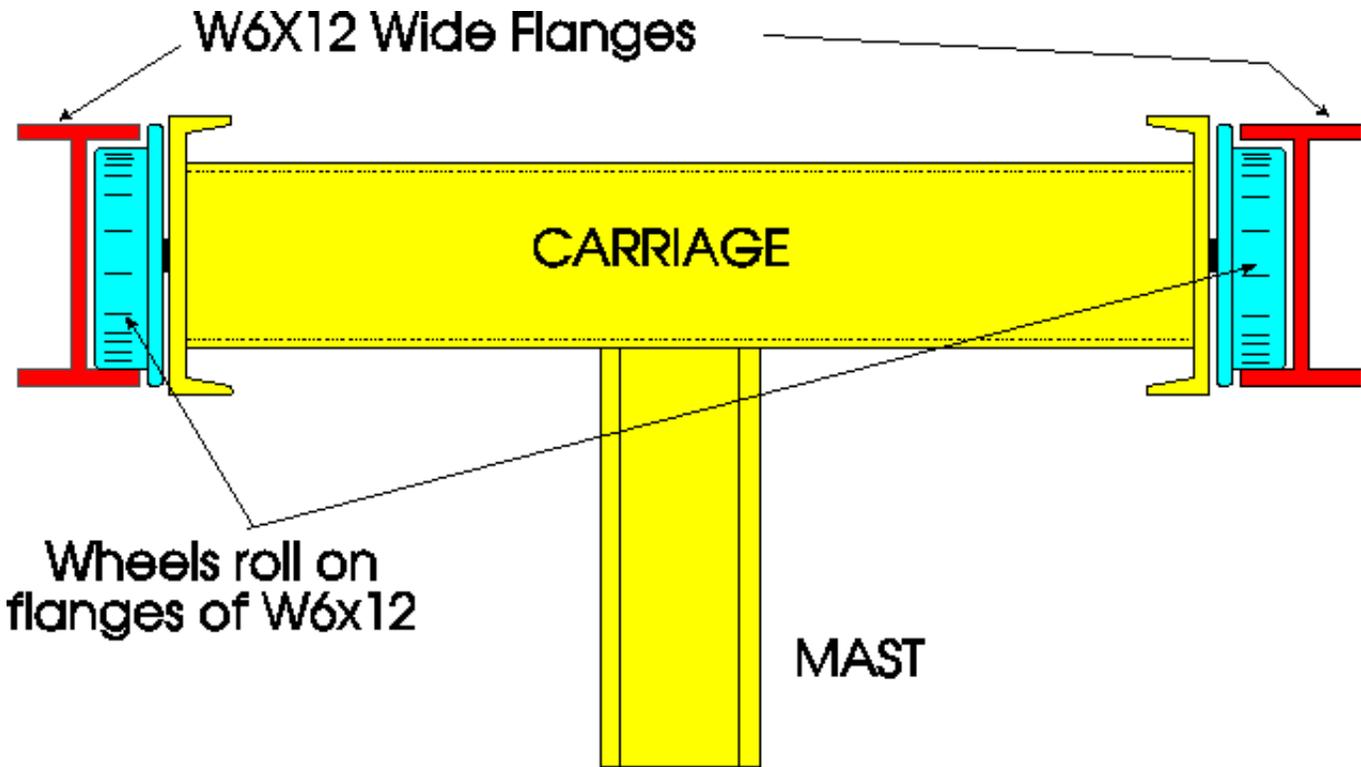
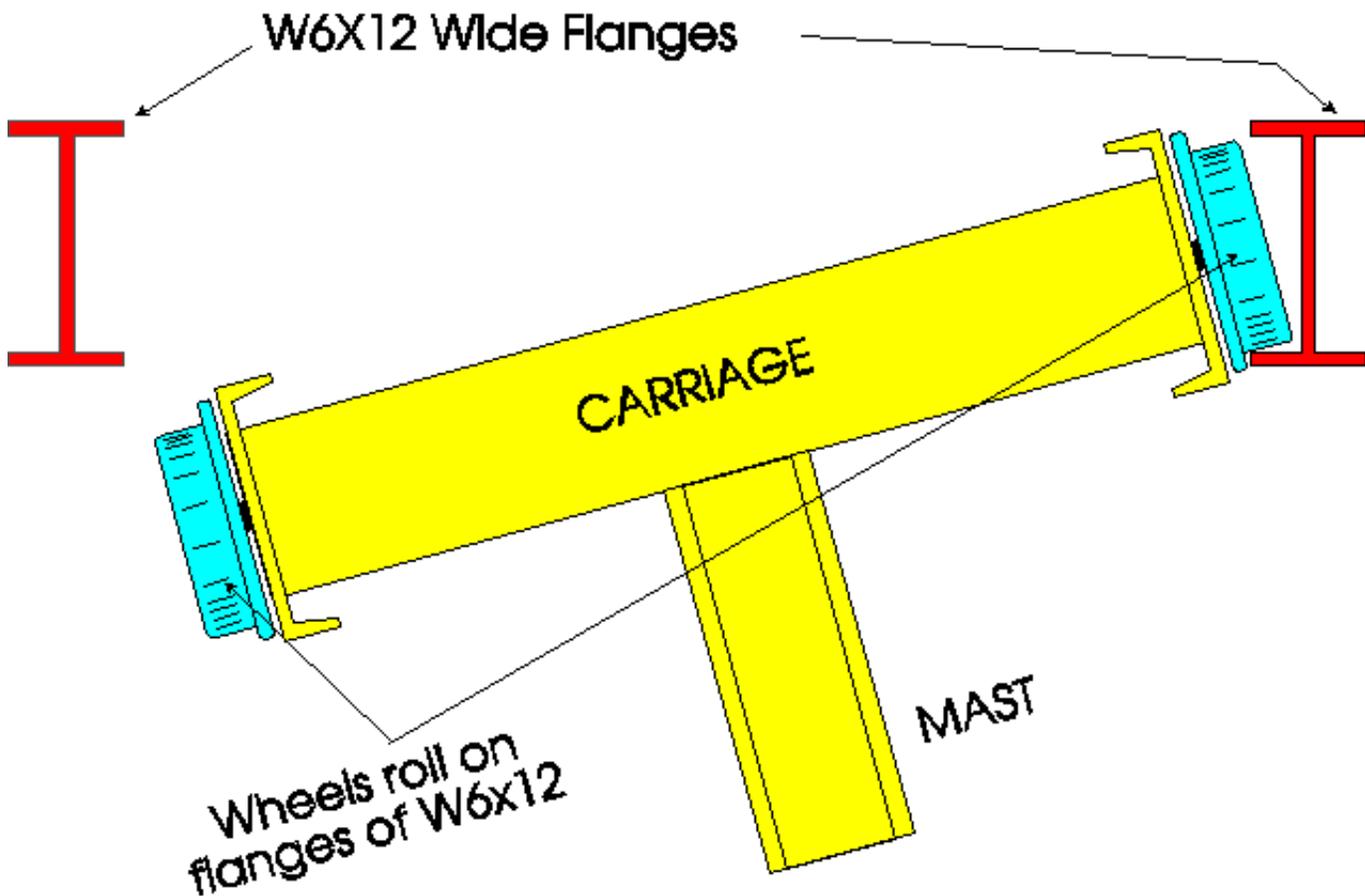
FIGURE 2

The accident caused the crane wheels on the back side of the pallet to be pulled free of the lower flange of the A588 steel W6X12 girder on the left side. (See Figures 2 and 3).

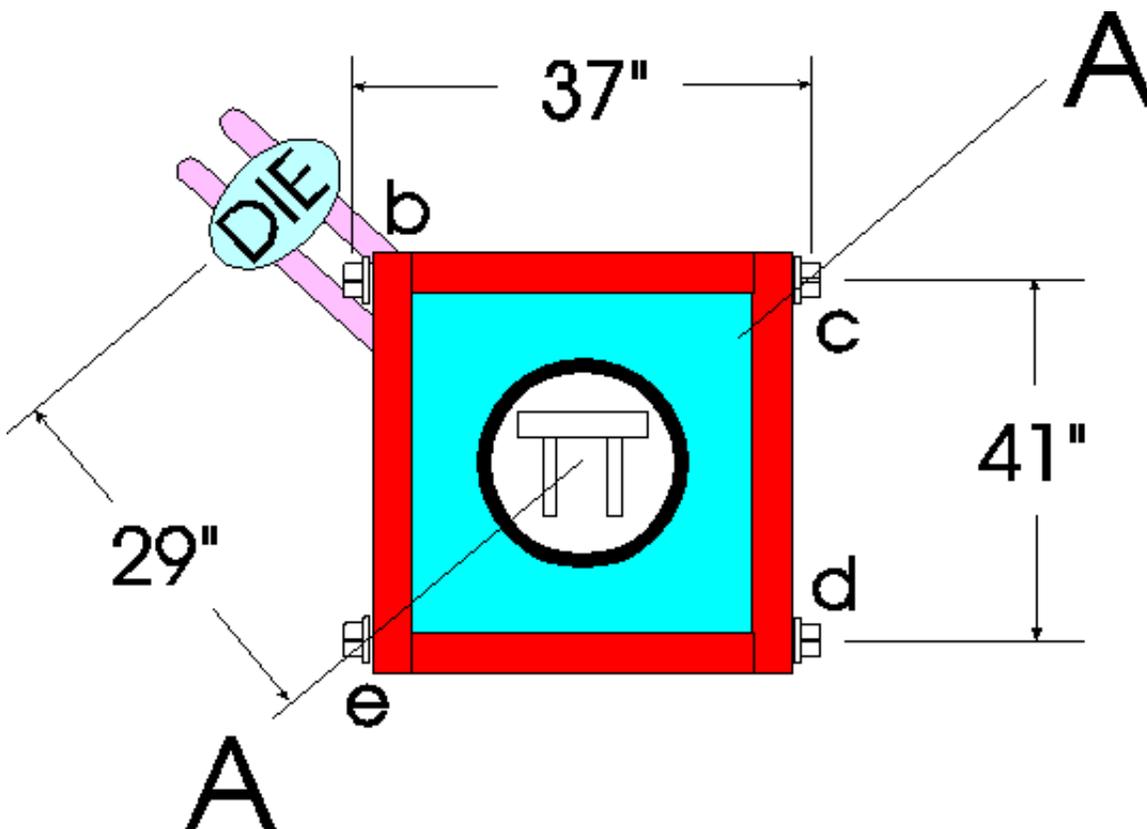
Figure 8

The maximum loading on the W6x12 beam is realized when the pallet and die are rotated directly over one of the carriage wheels, as shown above.

The die and pallet live load rating is 2000 pounds, and can be up to 29 inches from the center of rotation of the crane. The dead load of the crane itself is 1875 pounds, and is located at the point of rotation of the crane. Using AISC-LRFD design procedures, the factored live load, including a 10% allowance for impact (Section A-4.1 and A-4.2) is

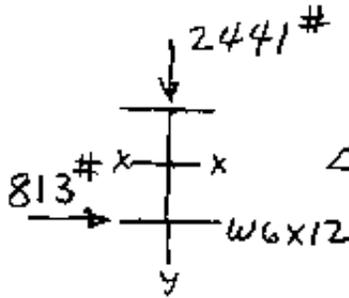
P2 is the maximum calculated wheel load, which is 1" off center. PL is the equivalent lateral load which gives the same torsional twist to the beam as did P2, when P2 is moved to a direct shear position. This lateral load causes significant bending about the weak axis of the beam, as shown in the calculations below.

$$P_L = \frac{2441 \times 1''}{3''} = 813\#$$

$$f_{\text{COMBINED}} = \frac{16.4}{12.39} + \frac{53.3}{27} = 1.32 + 1.97$$

$$= 3.29 >> 1.0$$

\therefore No Good
