# Events Surrounding the Fatal Accident of Aviasud Mistral Aircraft G-MYST on 23 June 2001.

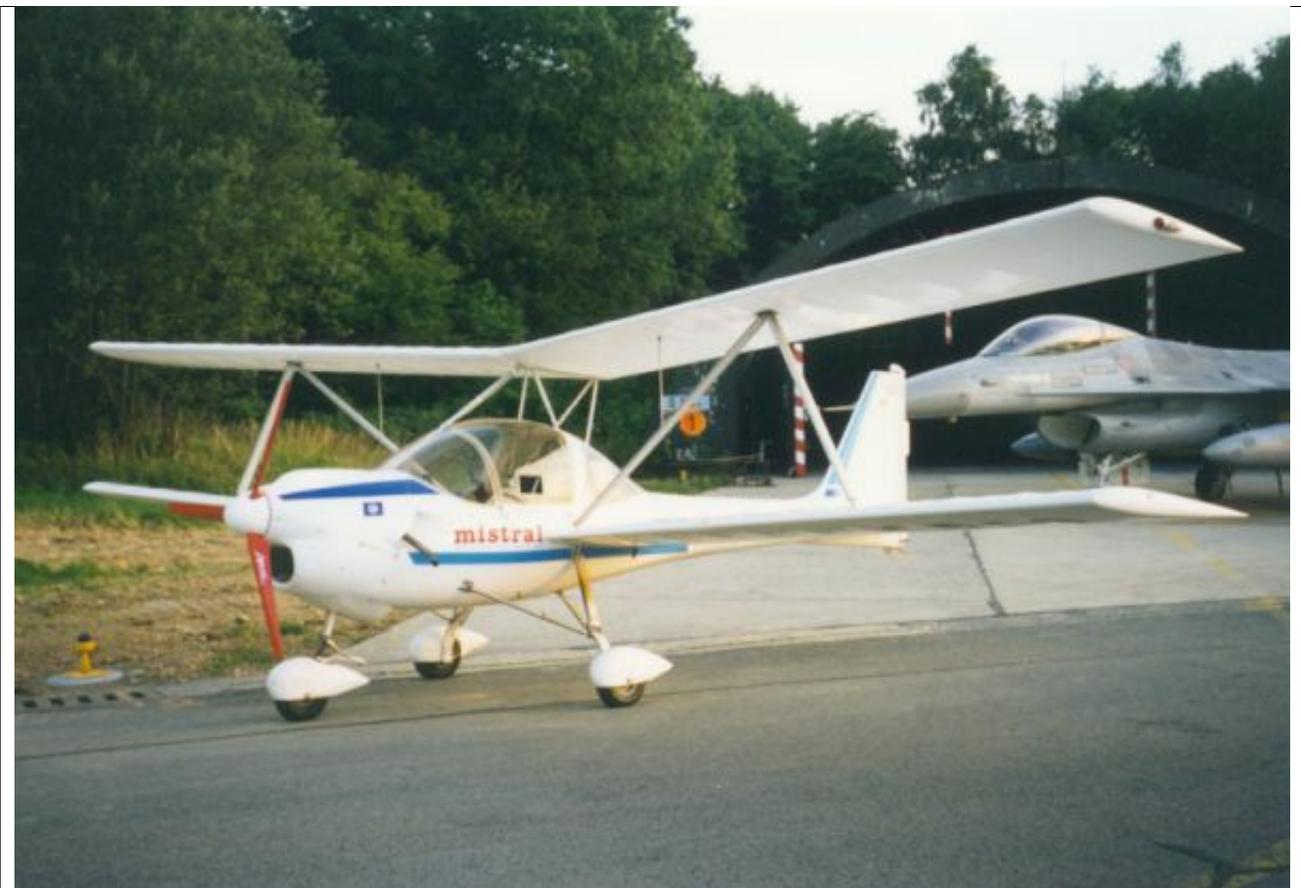
Figure 1, Aviasud Mistral (example shown is not a British registered example but external appearance is identical)

- The aircraft was fitted with a removable canopy (see figure 1). This was not fitted, yet on investigation throughout the UK certification testing of the type the canopy had been fitted, so there was no record of what changes removing the canopy made to the handling.
