ENGINEERING ETHICS

THE CASE OF THE LAKEWOOD "HI-STAK"

Department of Philosophy and Department of Mechanical Engineering
Texas A&M University

Accident Report

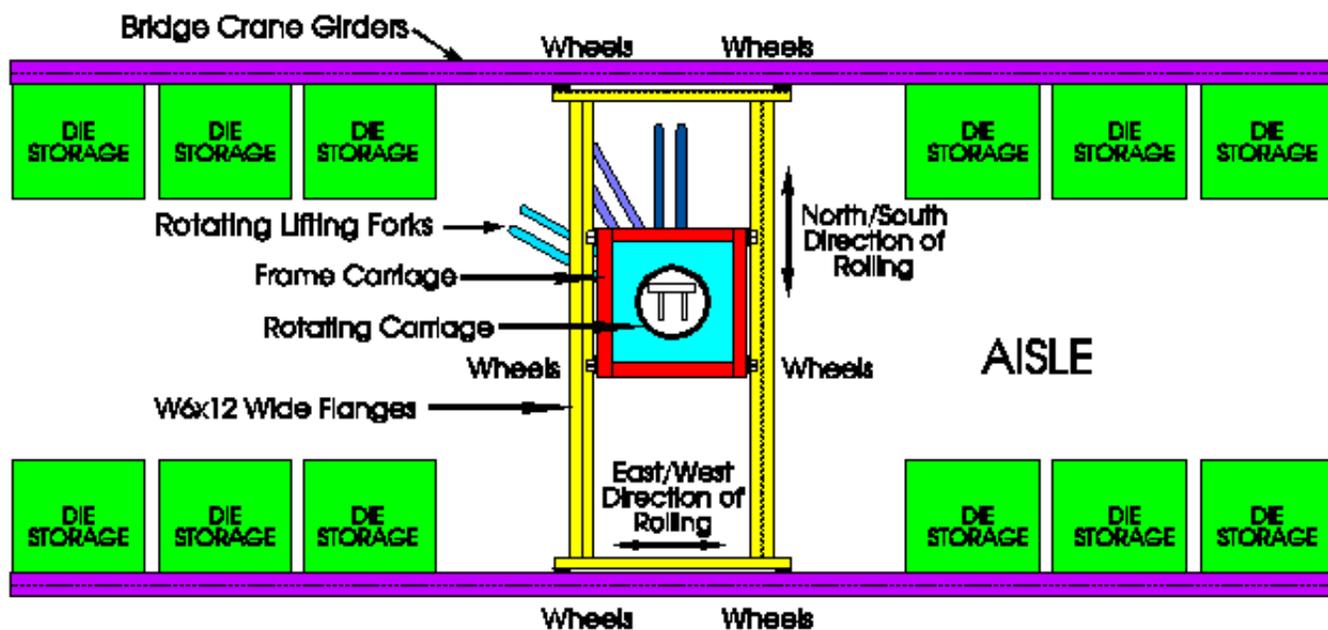
Figure 1

The Lakewood Company, a fairly large manufacturing firm, has designed, manufactured and sold hundreds of self-contained storage/retrieval systems which are used for storing heavy parts such as dies, which must intermittently be taken from storage and used elsewhere in the plant. The system consists of two large sets of storage racks, facing each other, with an integral crane that runs between them on 2 bridge crane girders on the top back edges of the storage racks (see Figure 1).
